PRELIMINARY INTERIM MEASURE COMPLETION REPORT

**REMOVAL OF PCB-CONTAINING CAULK
IN CONCRETE PAVEMENTS**

**Boeing Plant 2
Seattle/Tukwila, Washington**

February 2010

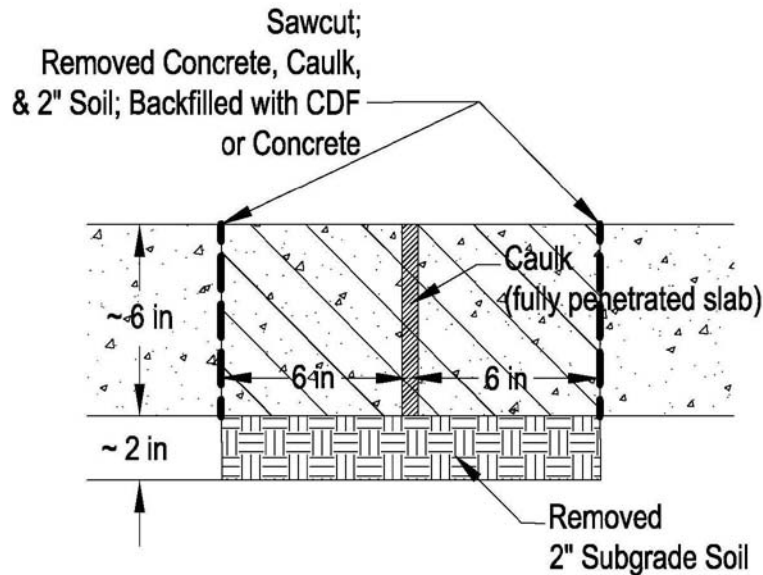
Sketch 1: Section of Typical Interior Joint in Concrete Slab in 2-60s Area
(not to scale)

The 2-60s Area concrete slabs formed the indoor floors of 1950s-era buildings that were primarily used for manufacturing and storage. The configuration between adjacent approximately 6-inch thick concrete floor panels in the 2-60s Area consists of a caulked joint that generally ranges in width from 1/8 to 1/2 inch, and fully penetrates the thickness of the concrete slabs (~6 inches), as shown in Sketch 1 below. A similar configuration exists in the joint between floor slabs and the much thicker perimeter curbs, footings, stem walls, or grade beams, as shown in Sketch 2 below

As the sawcutting progressed, the resulting 12-inch wide by 6-inch thick concrete and caulk segments were then removed using a small excavator. A few of the caulked joints contained lengths of caulk with PCB concentrations > 25 ppm and alternating lengths of caulk with PCB concentrations < 25 ppm. In such cases, both caulks were removed when the efficiency of the sawcutting and removal operations dictated such action. At perimeter joints, manual scraping and pneumatic scabbling were used as needed to remove adhered caulk from the perimeter curb, footing, stem wall or grade beam. Two inches of soil beneath the bottom of the caulk were then removed manually using shovels, and caulk or concrete chips adjacent to the removal slot were cleaned-up using brooms. The removed caulk, concrete and soil were placed in roll-off containers and appropriately managed for disposal. A total of approximately 2,660 linear feet of caulk containing > 25 ppm PCBs were removed from the 2-60s Area concrete slabs.

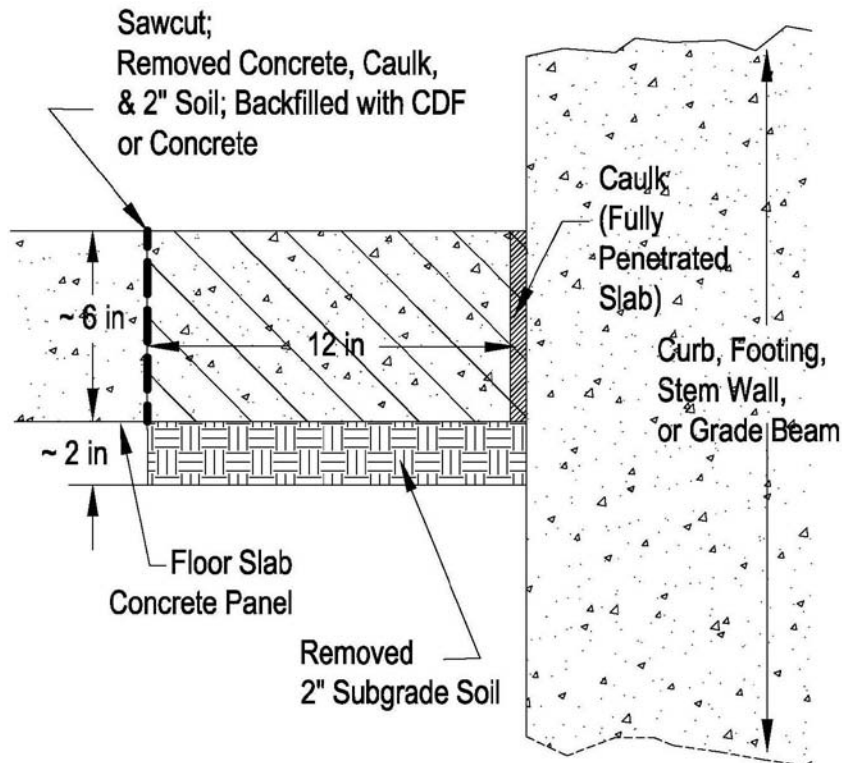
Sketch 2: Section of Typical Perimeter (Exterior) Joint in Concrete Slab in 2-60s Area
(not to scale)

As a result of the configuration of the caulked joints in the 2-60s Area, caulk removal required sawcutting through the full thickness of the concrete (approximately 6 inches), on both sides of the joints (approximately 6 inches from the caulk joints), per Sketch 1. In the case of perimeter joints between floor panels and curbs, footings, stem walls, or grade beams, the floor concrete was sawcut at a distance of approximately 12 inches from the perimeter structure, per Sketch 2.

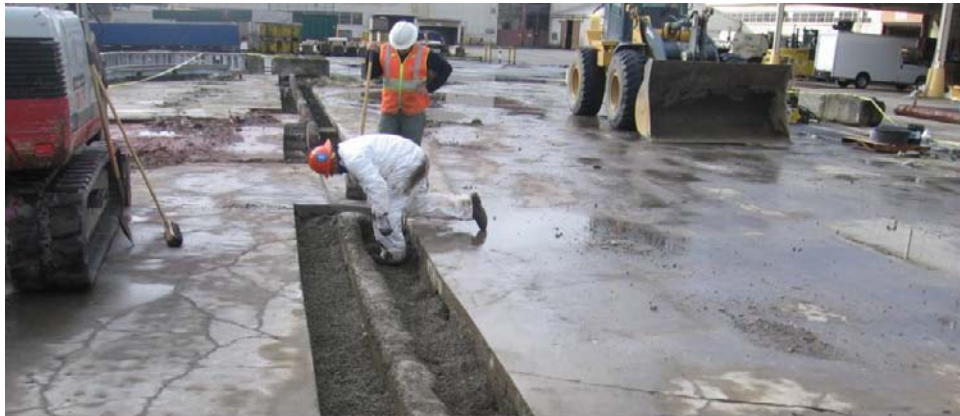
Preparing caulk-concrete removal slot for CDF backfill placement

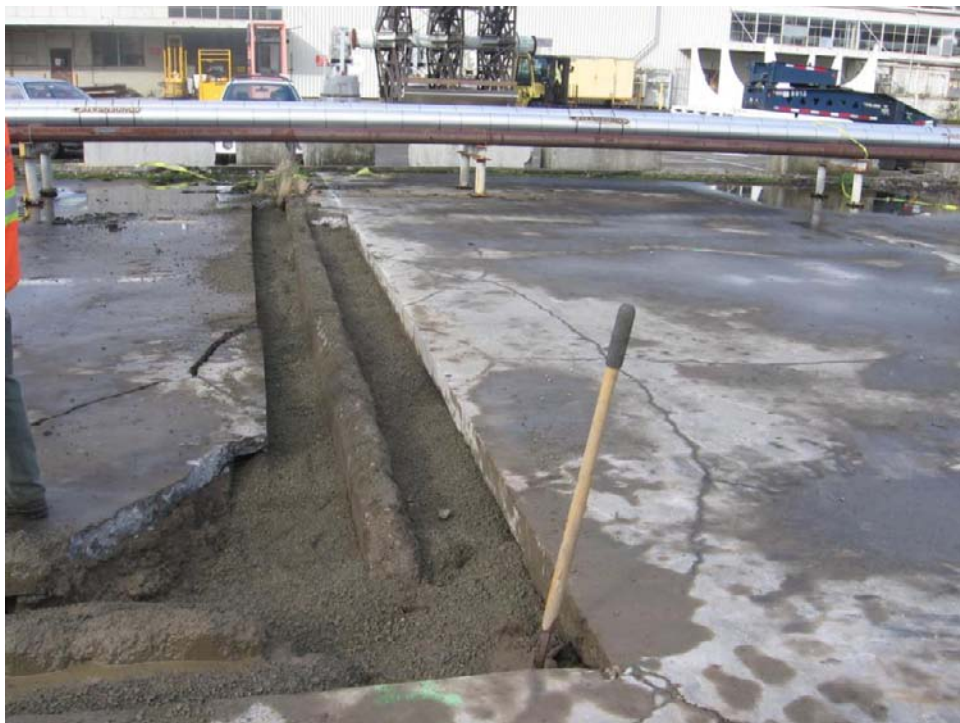
Preparing caulk-concrete removal slot for CDF backfill placement

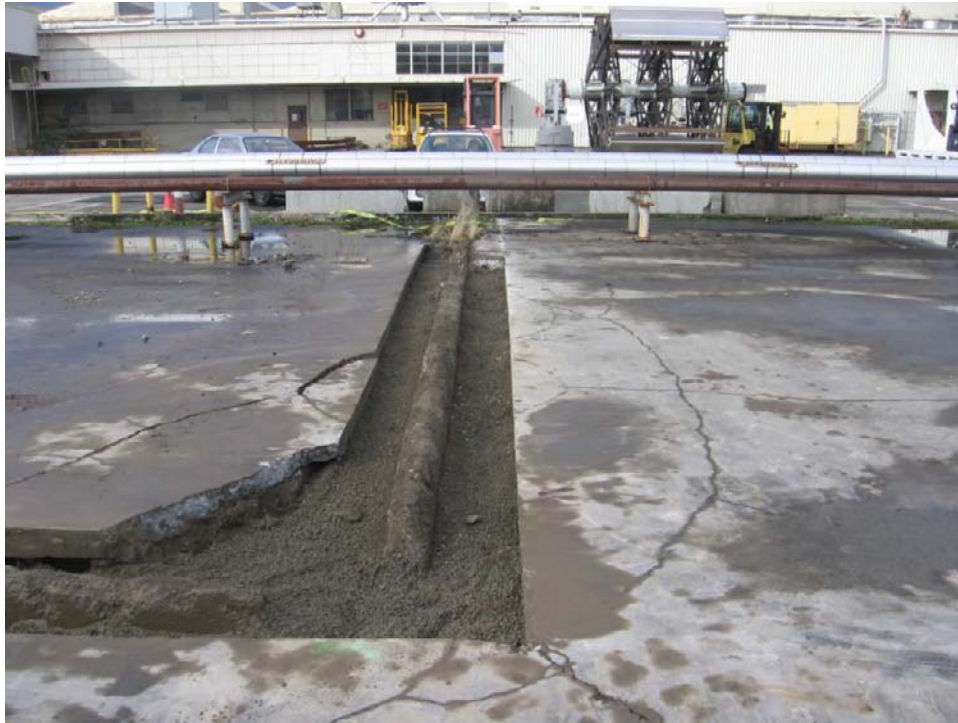
Caulk-concrete removal slot prepared for CDF placement

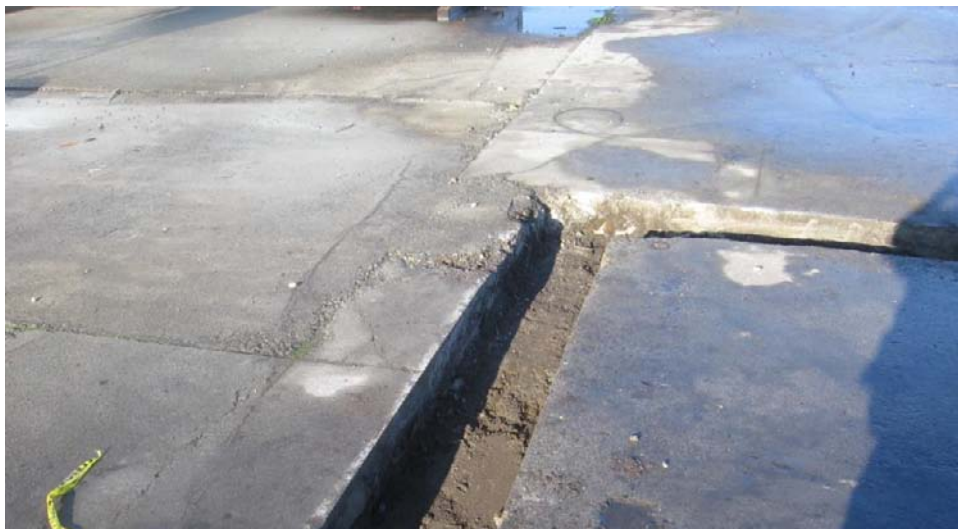
Caulk-concrete removal slot prepared for CDF placement

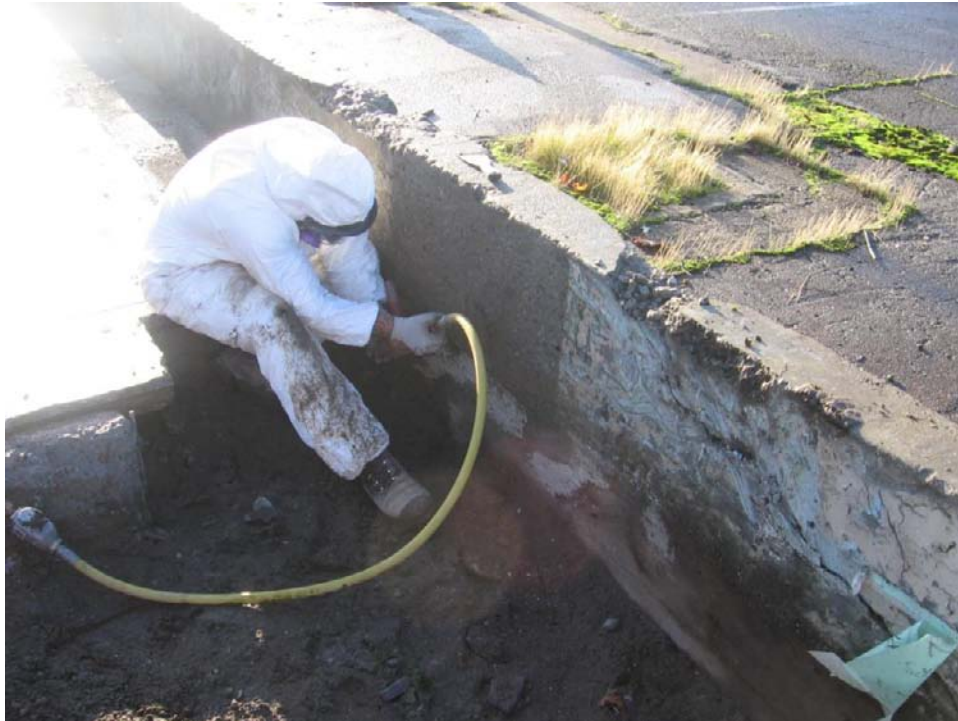
Using a pneumatic scabbler to remove adhered caulk from perimeter footing

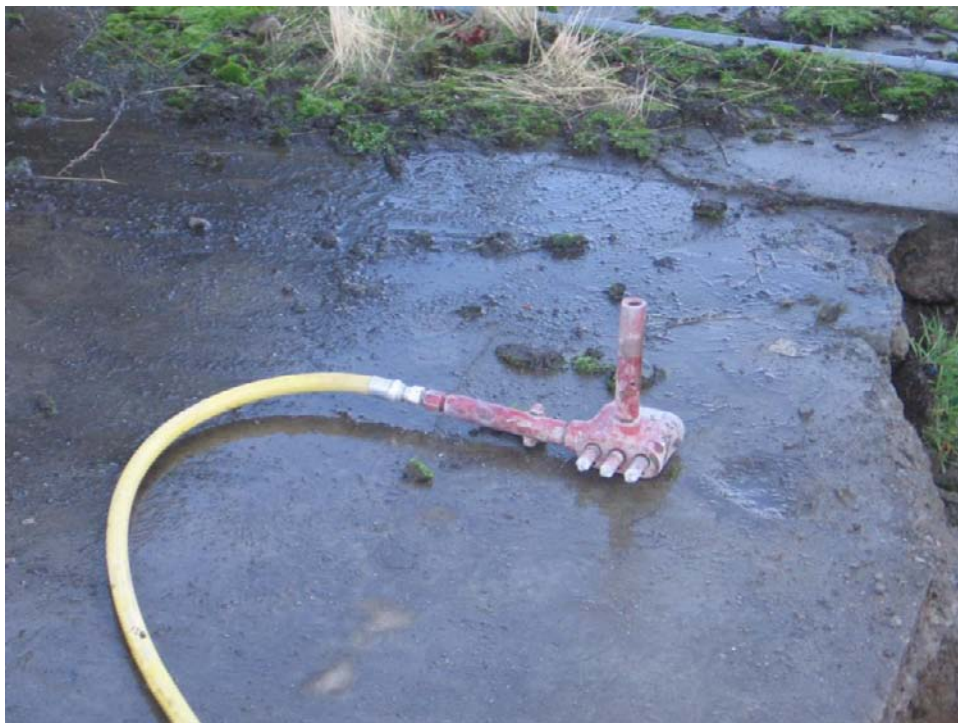
Pneumatic scabbler used to removed adhered caulk from perimeter footing

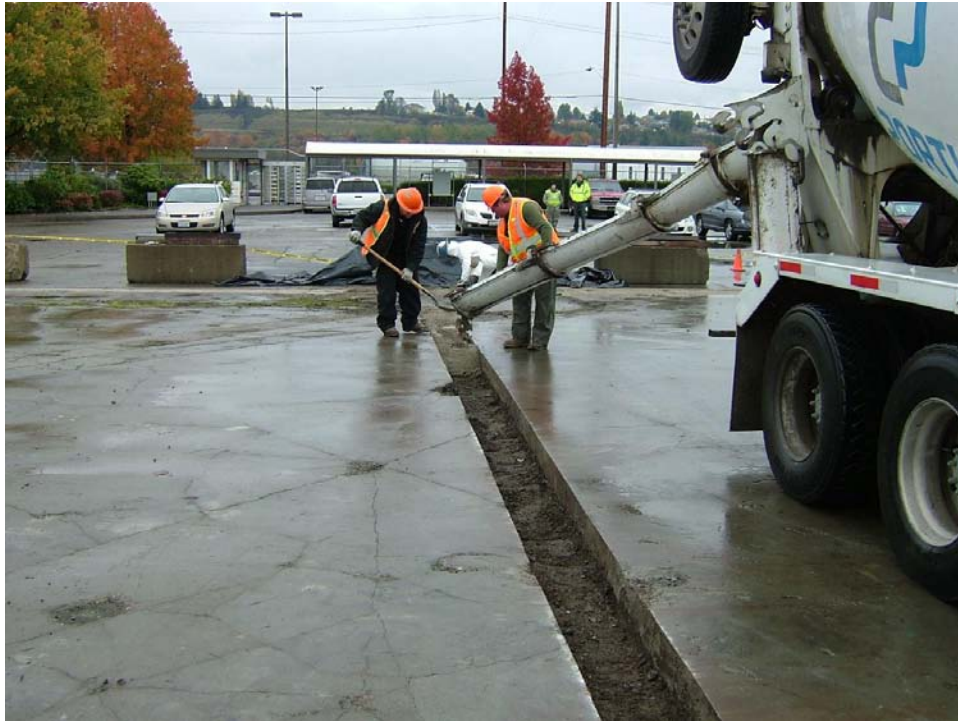
Placing CDF backfill in caulk-concrete removal slot

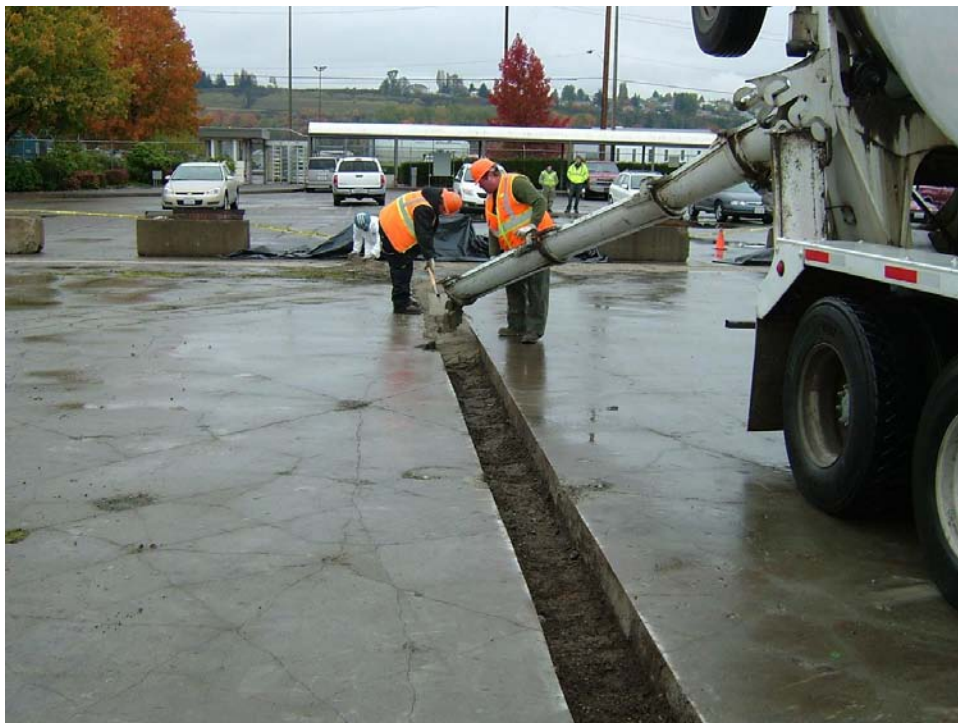
Placing CDF backfill in caulk-concrete removal slot

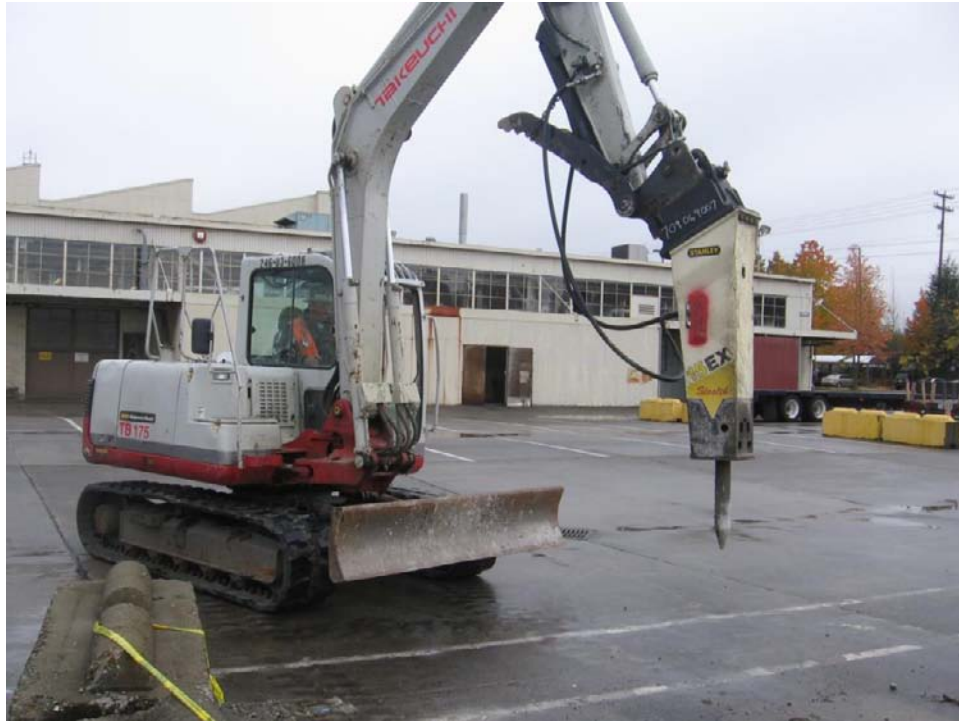
Pavement breaker used when joint or concrete configurations did not allow use of sawcutting machines
